Flood-Side Wave Erosion of Earthen Levees: Present State of Knowledge and Assessment of Armoring Necessity

Steven A. Hughes

August 2010

Final report

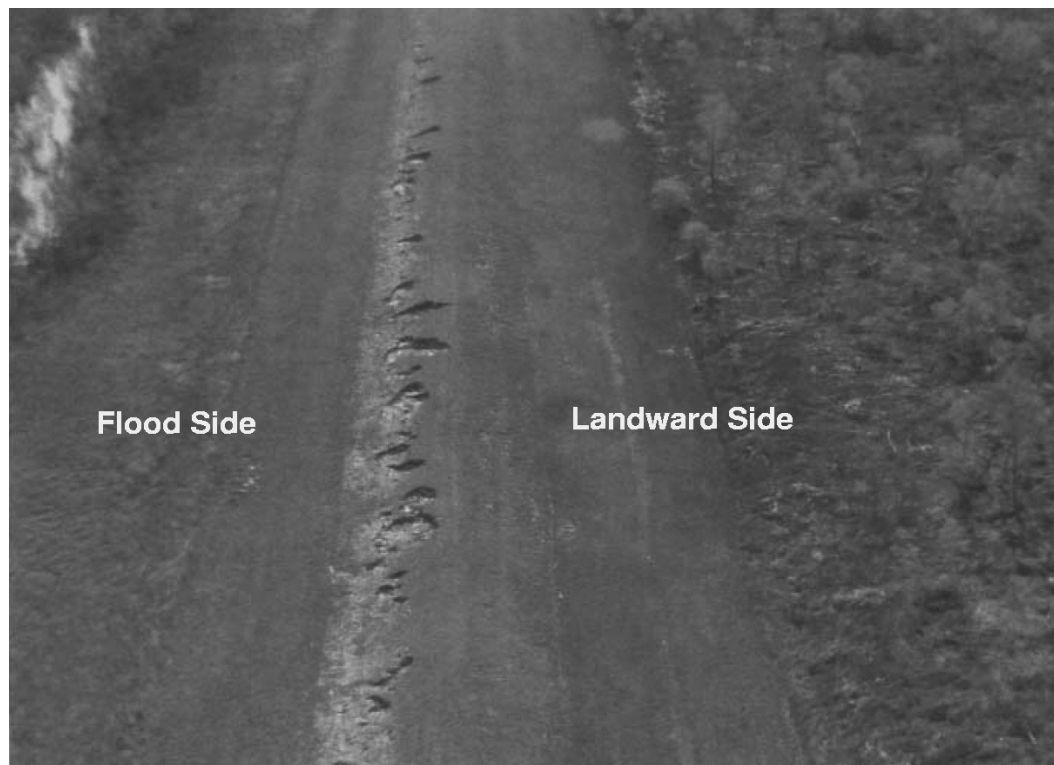
Figure 1. Wave damage on flood side of MRGO levee facing Lake Borgne.

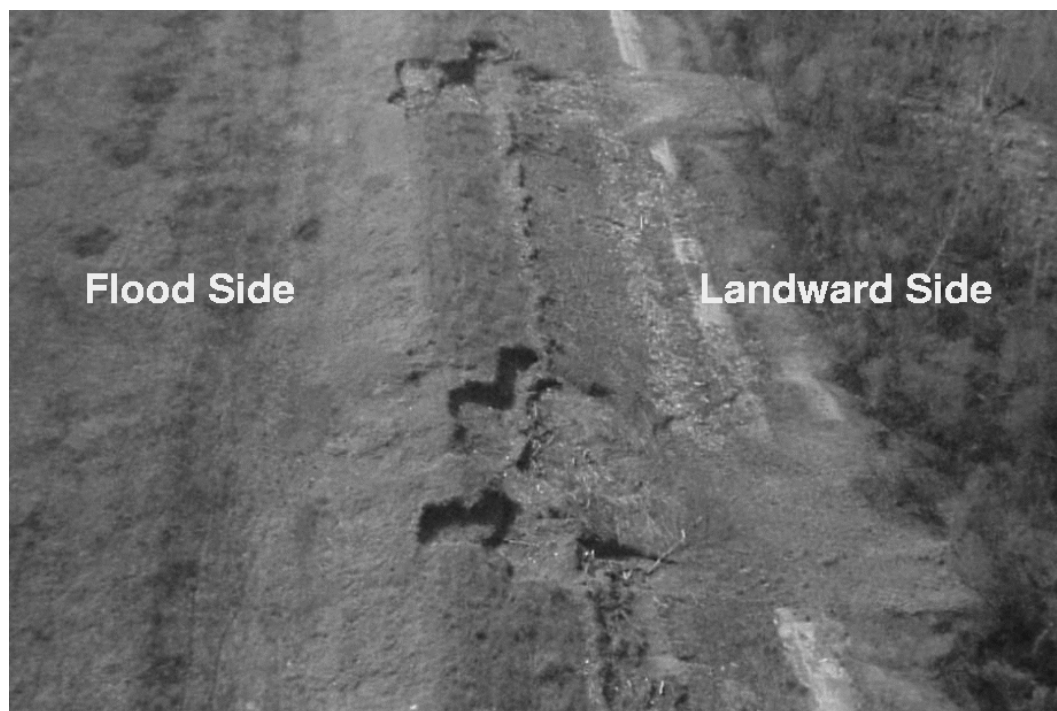
Figure 2. Wave overtopping or surge overflow damage on landward side of MRGO levee.

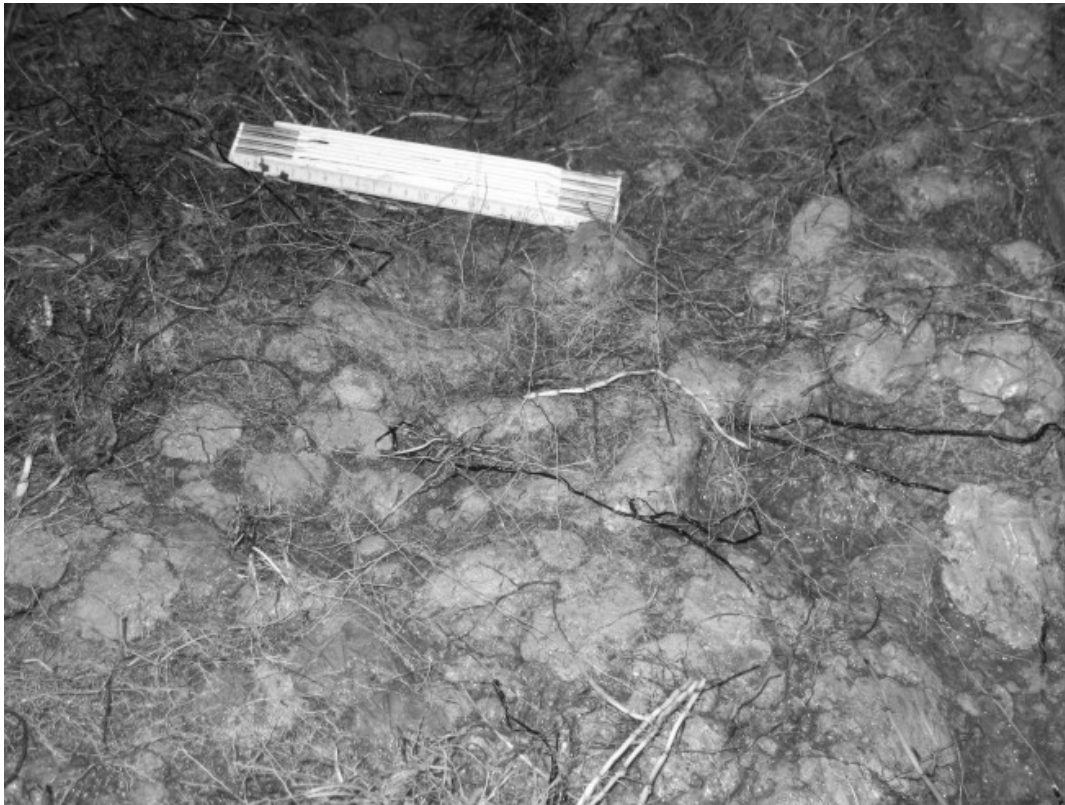
Over the cumulative duration of the test, several different types of damage to the grass cover were noted, and details are to be provided in a report that was still in preparation as of March 2010. Photographs taken at the end of the test indicated that the grass cover layer was (for the most part) intact with areas in the breaker zone where grass was removed, but most of the root system was still in place. Figure 13 shows some of the more severe damage.

Figure 13. Damage to the cover layer in the breaker zone (from Geisenhainer 2008).

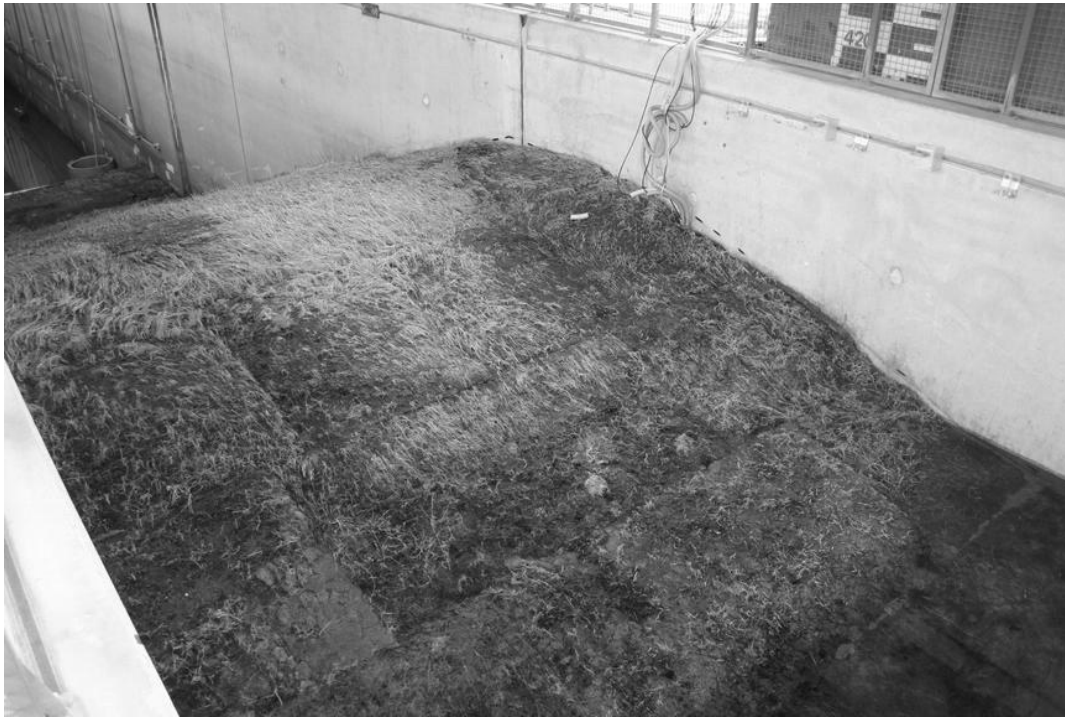
Figure 14. Flood-side grass cover during overtopping tests.
